ROOFTOP FAN MOTOR

Preventing Damage with Bearing Protection

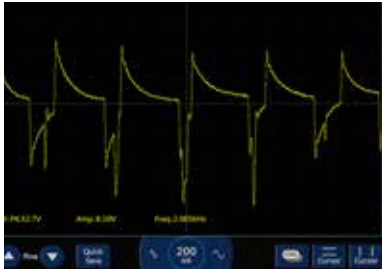
Both BPK Probe (17.4v) and Oscilloscope (32.7v) confirmed the high risk at different occurrences or instances

After measuring the shaft voltage with a BPK probe, it was quickly confirmed that this motor needed bearing protection. Peak discharges of 17.4 and 32.7 Volts were recorded at the time of measurement with probe and digital oscilloscope respectively.

This risk needed to be mitigated with an effective shaft grounding in order to protect the motor bearings.

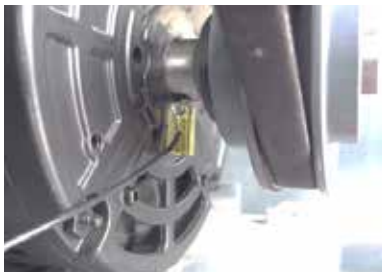
The BPK-IM2 was selected due to limited space. Installation was finished within 15 minutes.

The BPK-IM2 was selected due to limited space. Installation was finished within 15 minutes, as the maintenance department used 3M™ VHB tape and ground wire. The ground wire was soldered to the BPK-IM2 and then run to a proper ground location. The kit fit perfectly in the tight space.

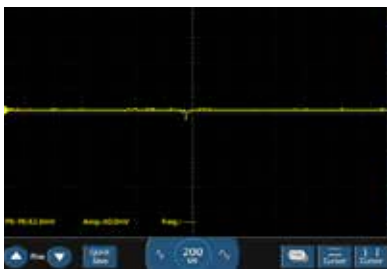
Measurements after install of BPK-IM2 on WEG motor.

The voltage measurements on shaft of the motor confirmed the effectiveness of the BPK. The peak voltage was reduced from 32.7 volts to less than 1 volt!
