CASE STUDY

SHAFT GROUNDING FOR SUBMERSIBLE PUMP MANUFACTURING

Shaft Grounding for Submersible Pump Manufacturing

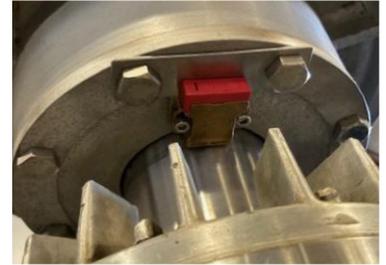
BPK-SB installed on a pump motor

From decades of experience, the engineers at Helwig Carbon knew the most effective way to prevent common-mode current from discharging through the bearings is to provide an alternative, least resistance path to ground. The BPK-SB featuring silver graphite technology was selected. This kit features a constant force spring, which puts positive force on top of a silver graphite brush. This allows for uninterrupted electrical contact between the brush and rotating shaft ensuring superior grounding. The material provides effective grounding at high and low frequencies and is very low friction to allow for extra -long life. It was also of great importance to the pump manufacturer to find a solution that required no additional maintenance from the end-user. The BPK-SB is sealed from contaminants and the silver graphite grade provides cleaning action to the motor shaft surface ensuring years of performance with no extra maintenance required. Finally, installation costs needed to be considered. A custom bracket was designed for easy installation on the assembly line or in the field. Overall, the BPK-SB package will provide economical and effective insurance against bearing failure due to electrical discharges for many years.

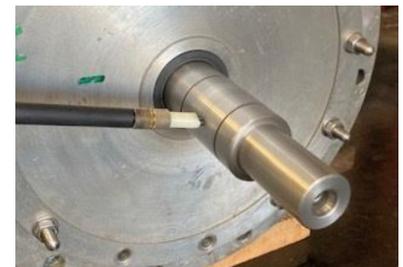
Testing shaft voltage with BPK-Probe

Helwig tested the pump motors at the customer's facility with and without the BPK on the shaft to ensure the solution is working. Various pump motors were hooked up to a VFD and ran using typical field operating conditions. The motors were then tested with and without the BPK solution using the BPK-Probe. Results showed that the motors without the BPK engaged showed shaft voltages of over 12 volts, which is well above the 2 volts threshold for bearing damage. When the BPK solution was engaged, the shaft voltage dropped to under 1 volt. This showed the Helwig Solution was providing the appropriate protection of the pump motors and will eliminate bearing failures from electrical discharge machining.
